BY VYTENIS BABRAUSKAS, PH.D., ISSAQUAH, WASHINGTON—A sizable fraction of ignitions of structures are due to electrical faults associated with wiring or with wiring devices. Surprisingly, the modes in which electrical faults progress to ignitions of structure have not been extensively studied. This paper reviews the known, published information on this topic and then points out areas where further research is needed. The focus is solely on single-phase, 120/240V distribution systems. It is concluded that systematic research has been inordinately scarce on this topic, and that much of the research that does exists is only available in Japanese.

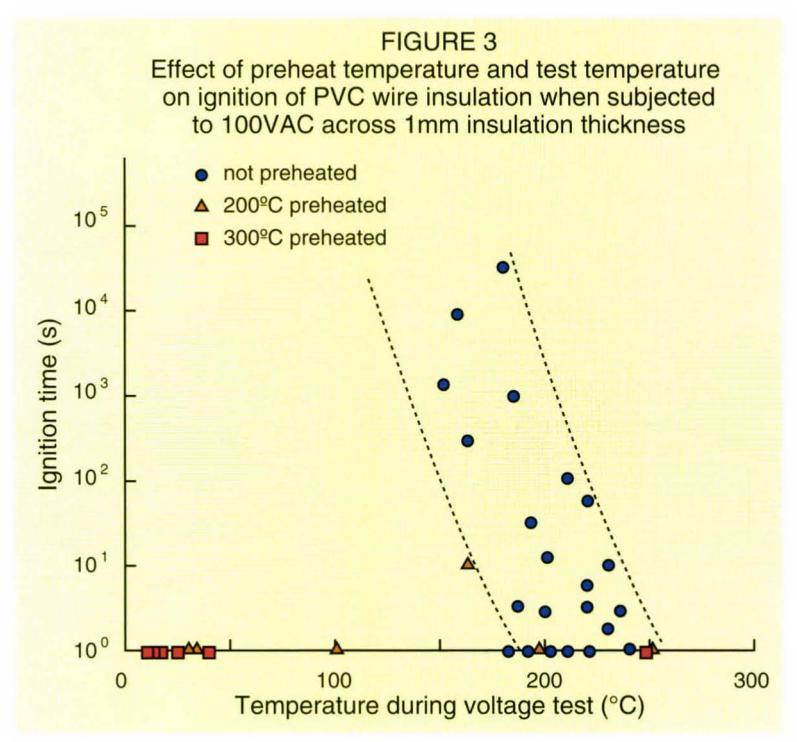
When PVC is exposed to temperatures of 200–300°C, it chars and the char is a semiconductor. Not surprisingly, this can lead to leakage currents and arcing. But Nagata and Yokoi¹³ found that if virgin PVC was heated to the rather low temperature of 160°C, impressing 100V across 1 mm of insulator thickness was sufficient to cause ignition of the insulation. Furthermore, if the insulation had previously been preheated to 200–300°C, then ignitions occurred when the preheated insulation was raised to only very mild temperatures during the voltage test—from room temperature to 40°C—were found sufficient (Figure 3).

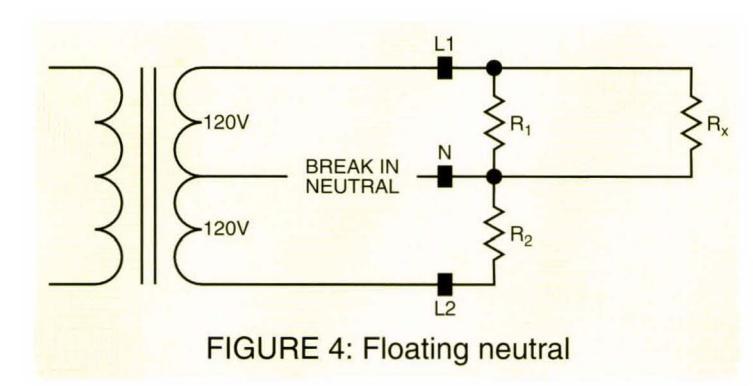
Lightning strikes can result in massive ignitions, not just of wiring, but of all sorts of combustibles. The problem has generally not been studied in connection with 120/240V wiring systems. Occasional fire reports are encountered where, due to some malfunction in the power distribution network, high voltage got applied to wiring intended to carry only 120/240V. These cases are rare enough that no systematic study exists. Floating neutral problems are a bit less rare, but again, no systematic studies exist. The basic problem is illustrated in Figure 4. A normal load, such as R_x , expects to see 120V presented to it. But if a break in the neutral occurs, it will be presented with a voltage that can range from slightly above 0, up to almost 240V; the exact value is determined by the other loads on the system, R_1 and R_2 . Ignitions are not surprising in such circumstances.

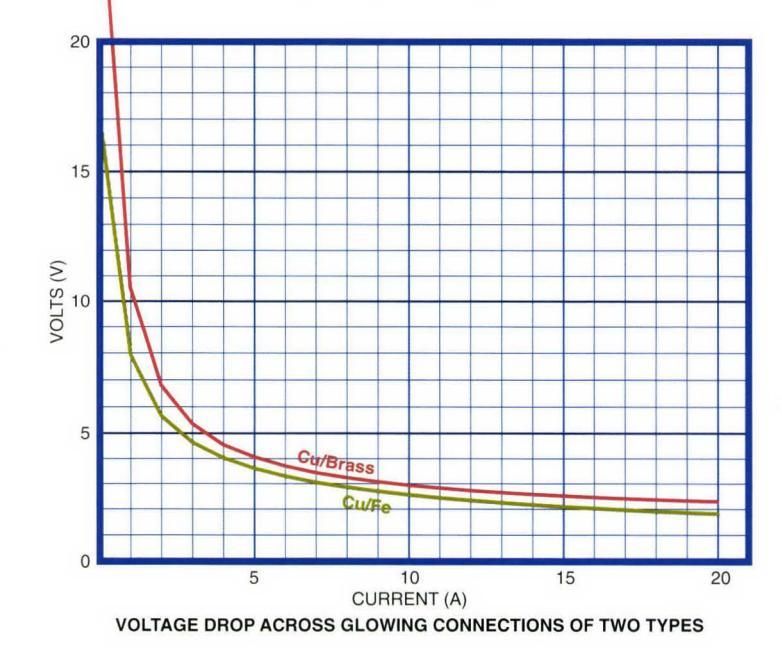
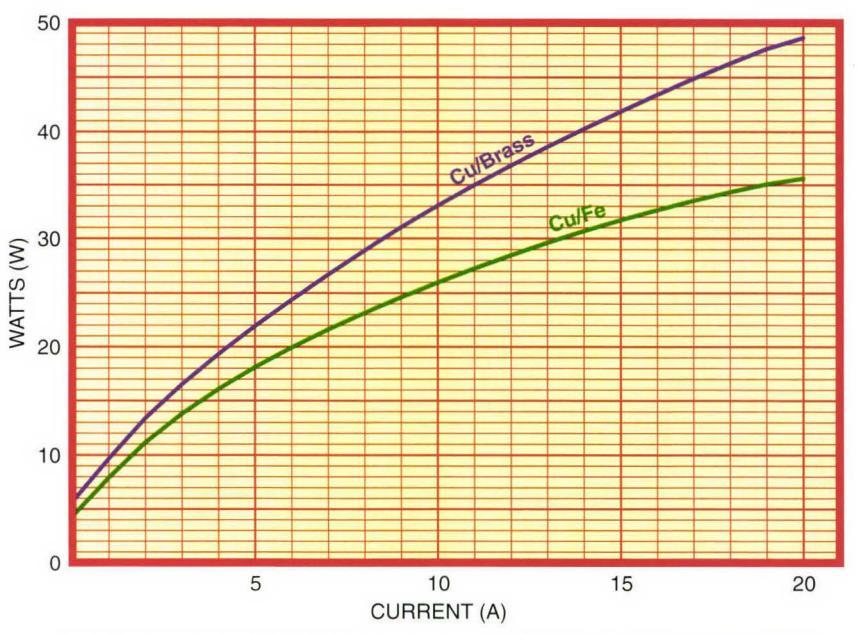
POWER DISSIPATION ACROSS GLOWING CONNECTIONS OF TWO TYPES

One of the earliest efforts to study glowing connections dates to 1961³⁶. The primary results are shown in the two figures to the right. The connection acts as a non-linear circuit element. For currents over 10A, drops of around 20V were found. But for small currents, voltage drops in the tens of volts can be found. At a maximum current of 2A, ca. 50W is dissipated in a copper/brass connection and around 35W for copper/iron. The study noted that the power dissipation depends only on the materials involved and not on the nominal size of the contacts. It was also found that to start the glowing process, a current of 4–6A had to be supplied; glowing of freshly-made connections could not be started with smaller currents.
